OTIS COMPANY DAM NO. 1

NH 00041

PHASE I INSPECTION REPORT
NATIONAL DAM INSPECTION PROGRAM

MARCH 1979

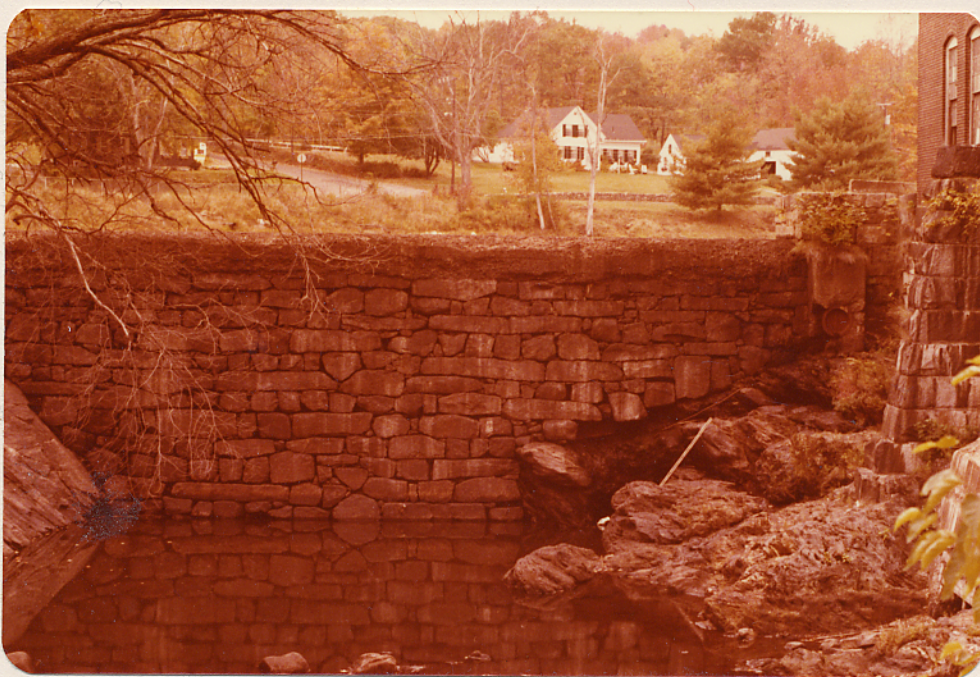
Overview from road bridge downstream
of dam

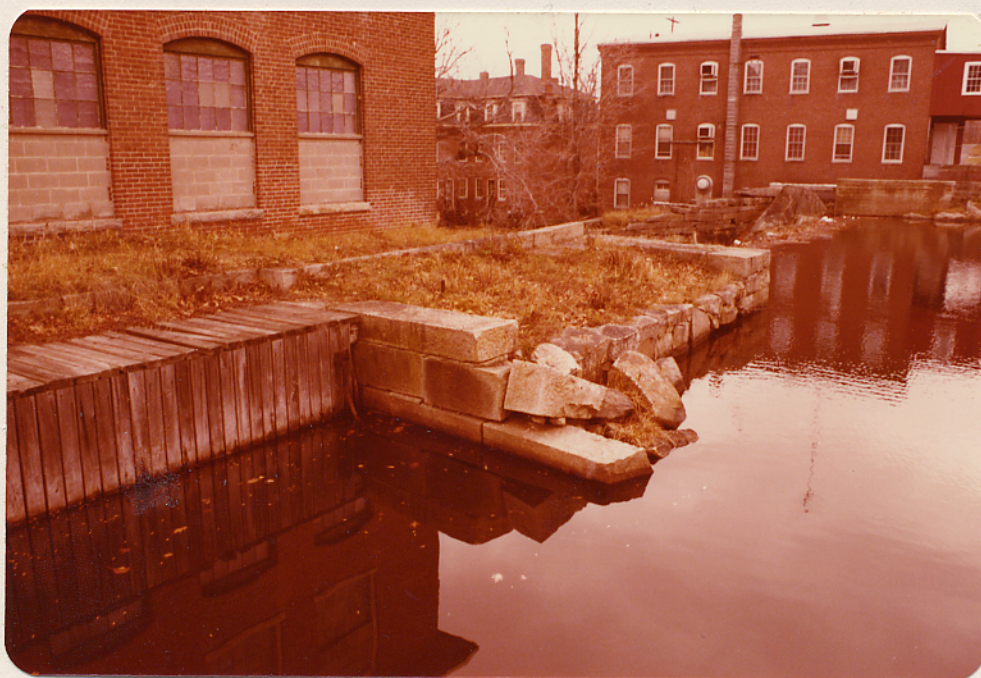
Overview from upstream left side
of dam

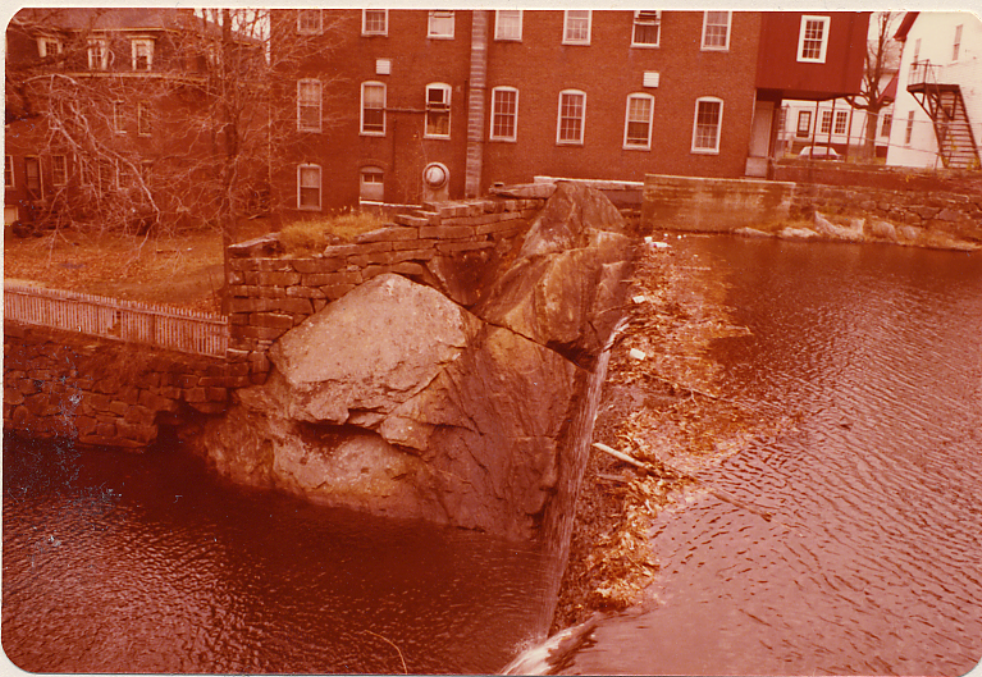
1. View from left side of spillway of bedrock outcrop forming right abutment

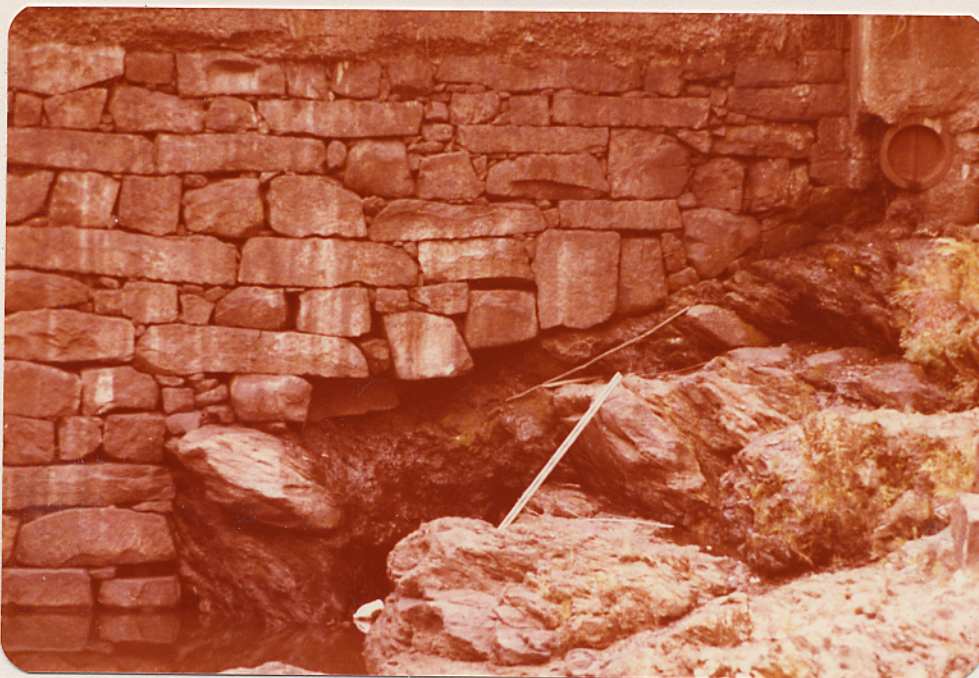
2. View from downstream channel showing bedrock under left side of spillway and abandoned waste gate

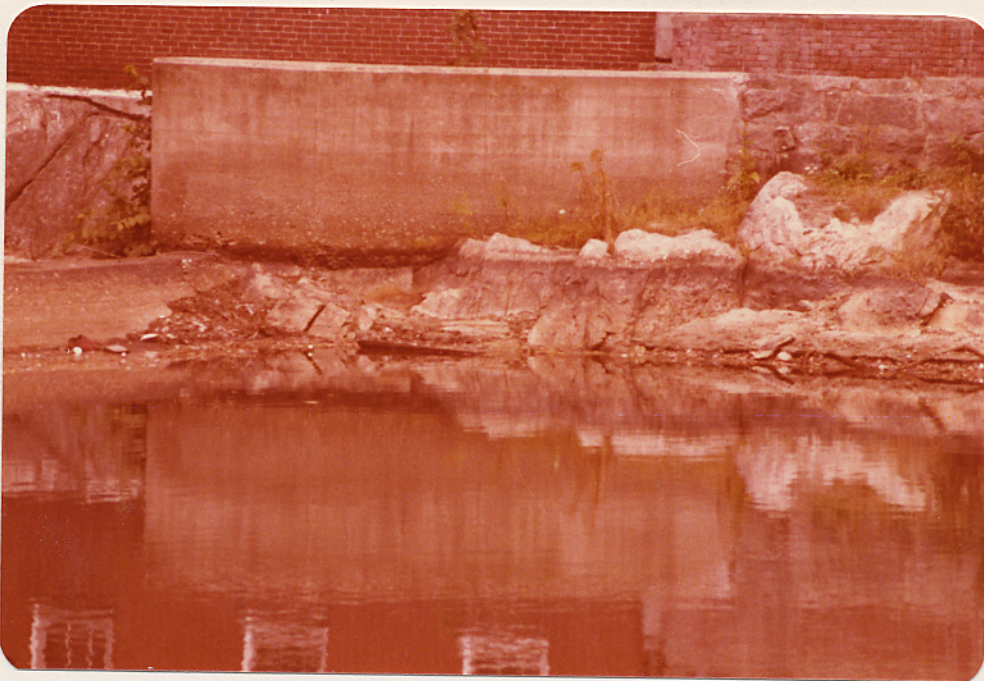
The base of this structure is eroded for a length of 10 feet where it abuts the spillway. This erosion is approximately 2 feet in height and up to 12 inches deep. The base of this structure at the interface with the spillway crest is eroded in excess of 2 inches. The remaining portion of this structure is in good condition with no evidence of spalls, cracks, or efflorescence.

3. View from left end of spillway of concrete erosion at junction of spillway, right abutment, and right upstream training wall

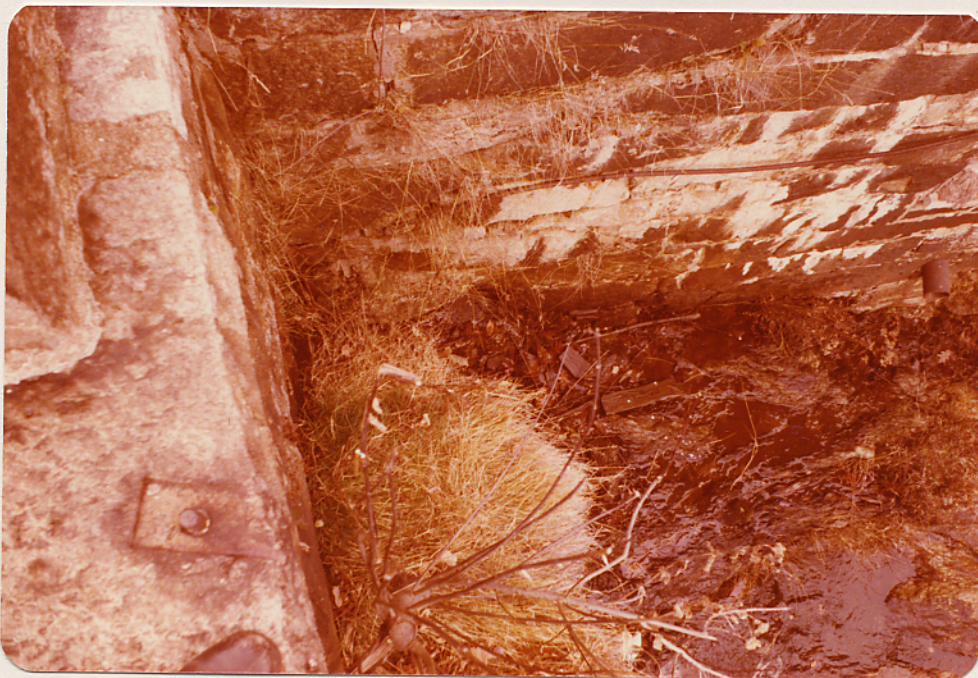
4. View from top of dam of seepage at junction of mill building wall and left end of spillway

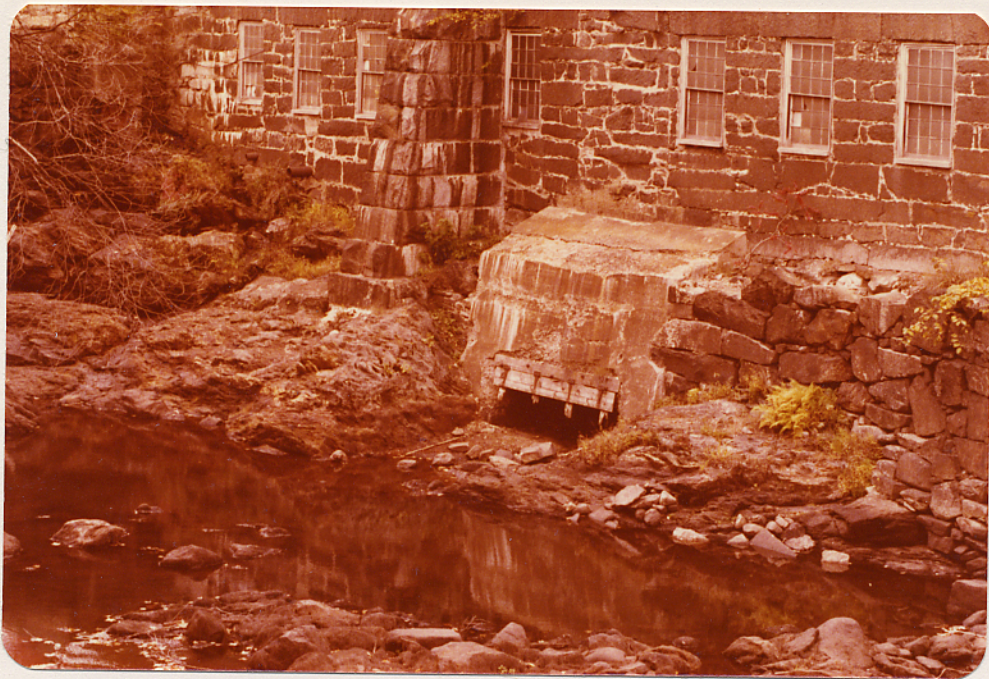
The concrete tailrace outlet is spalled over 50% of its exposed faces. This spalling is attributed to moisture intrusion which has been subjected to alternating freeze and thaw cycles. The base of the structure is eroded from the channel invert for a vertical height of approximately 3 feet. This erosion is attributed to cavitation and ice damage. The timber flap gate has been completely destroyed. The condition of the tailrace outlet is not serious since it is no longer used.

5. View of discharge channel outlet for old power works in mill building basement from right side of downstream channel

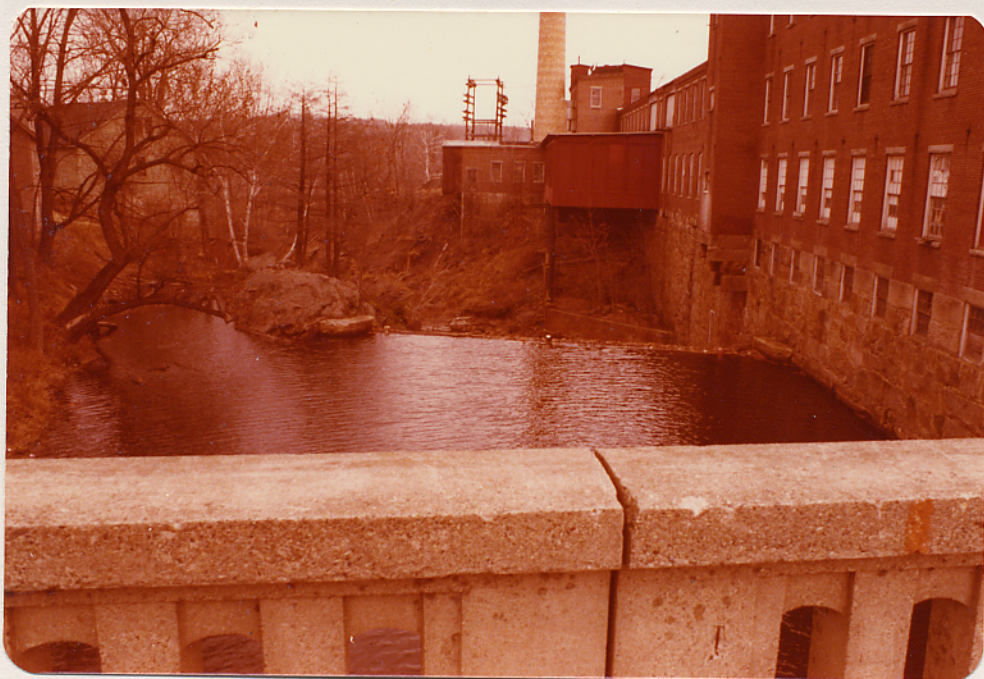
6. View from road bridge showing old mill dam just downstream of bridge

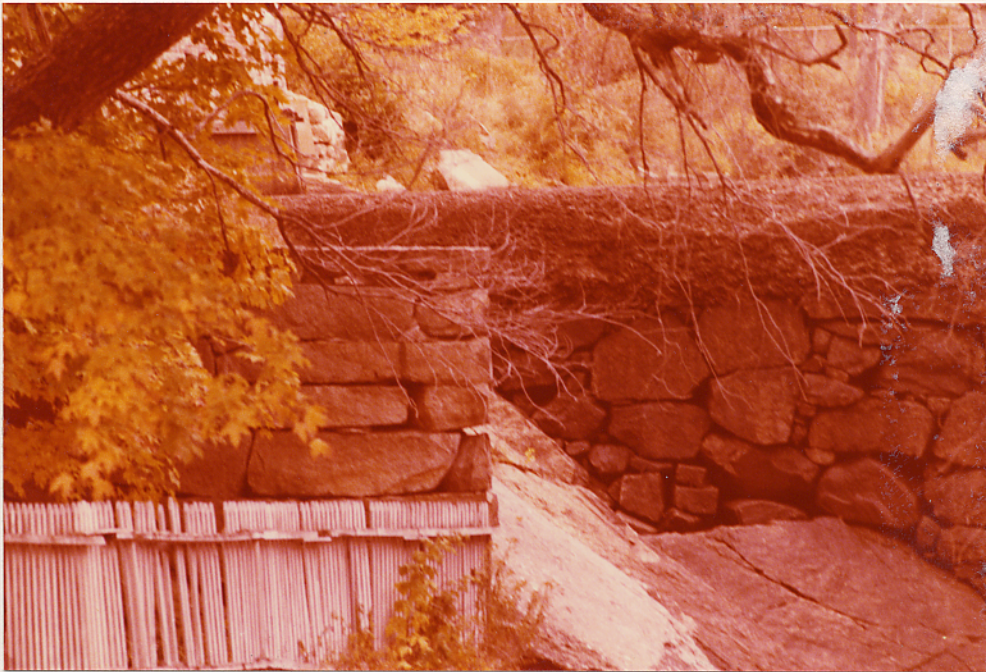
Visual observations revealed that the concrete cap on this structure is severely eroded over its entire length. This erosion is attributed to cavitation and ice damage. The downstream face of the spillway, adjacent to the right spillway end wall, is eroded over a distance of approximately 8 feet, a depth of 18 inches, and a vertical height of 18 inches. The top of the spillway

at this point is eroded over its top 3 foot width, for a distance of 3 feet, and to a depth of 2 inches. This erosion is attributed to ice damage.

7. Deteriorated concrete cap of spillway
as viewed from the downstream right
side
